**PLAINTIFF'S DESIGNATION OF EXPERT WITNESSES**

**Amended Expert Report for Andrew M. Hendrick, Esq.**

RE: ***DOUGLAS I. Hornsby, Administrator of the Estate of CYNTHIA GARY v. United States of America et. al***

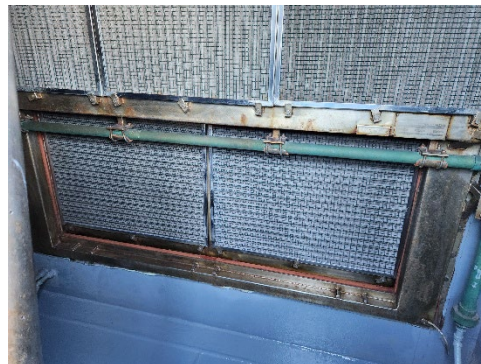
Figure 1. Blow-in Door Panel from Outside

Figure 1 is a photo of the outside of the Blow-in panel or BID also known as the “dirty” side of the combustion air intake. Figure 2 is a photo of the inside of the BID also known as the “clean” side. The door/panel opens only about 35 degrees. The BID opening has been used, as in this case, as a convenient access for welding and miscellaneous supply for work in the uptake passages.

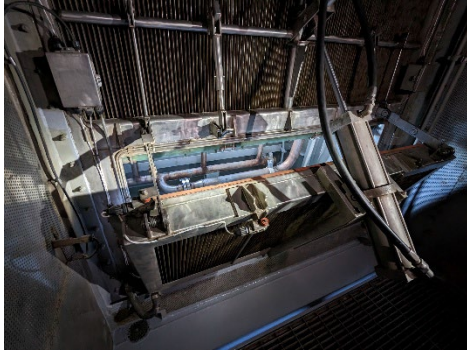
Figure 2. Blow-in Door from Inside

The control switch provides a signal to a solenoid actuating valve which allows air pressure to open and close the door through a pneumatic cylinder which can be seen in the Figure 2 photo.

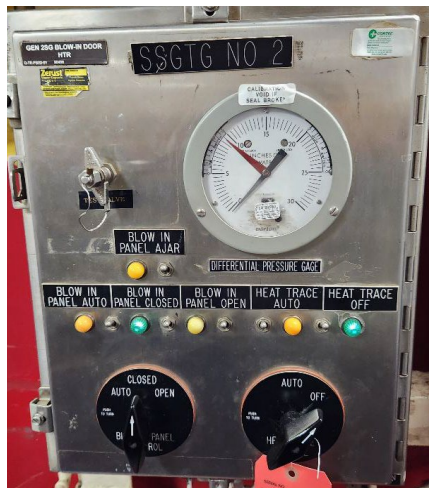
Figure 3. Blow-In Control Panel for #2 SSGTG

By placing the lower left rotary switch, shown in Figure 3, in the AUTO position the operator permits the BID to open automatically whenever differential pressure exceeds allowable limits. This is the normal operating position. *(For safety purposes, to keep the switch from being inadvertently turned, the switch was designed to only be turned by first pressing it inward slightly before actuation.)* By placing the switch in the OPEN position, the automatic function is bypassed, and the door is held open regardless of the differential pressure until the switch is turned to CLOSE. I have shown in Figure 4 a rough schematic of the system functioning.

- According to his deposition, GSCS Goff went to the scene of the accident when he heard the notice over the announcing system. After working to free Ms. Gary and once the medical corpsman was on site, he went immediately to the #2 engine room to check the controller, Figure 3. He stated that the switch was set at the closed position and looked like it had been slightly bent. He noticed a danger tag in place on the switch selector.

- GSCS Goff also mentioned in his deposition that he was not aware that the push-to-turn function of the control station selector switch was not working properly until it was checked after the accident. He mentioned that the switch was able to turn without depressing it first.

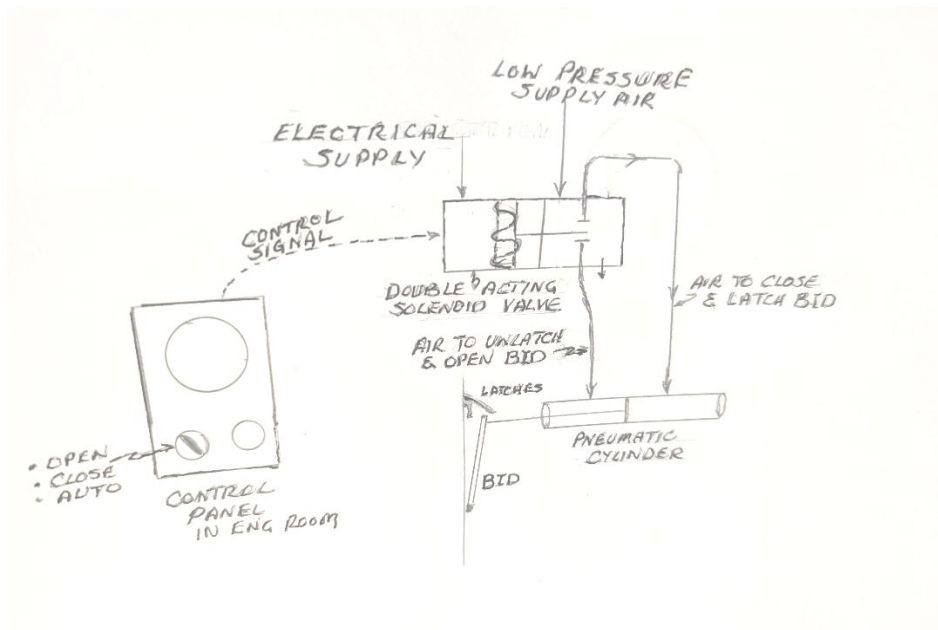
Figure 4. BID Control System Schematic

- The BID control switch should then be tagged out open.
- For the BID to have powered to the closed position there had to have been electrical power and air pressure to the solenoid actuator plus a control signal from the controller to the solenoid. See Figure 4.

- With the system energized set the selector switch on the control panel to “open”.
  - Then remove LP air and tag-out the LP air supply valve closed. The door should still be open.
